# Inspection Report

**Company** Geothermal-Solar  
**Address** Longston Lodge, Kilgowan,  
Kilcullen, Co.Kildare  
**Thermographer** Erik Vaughan

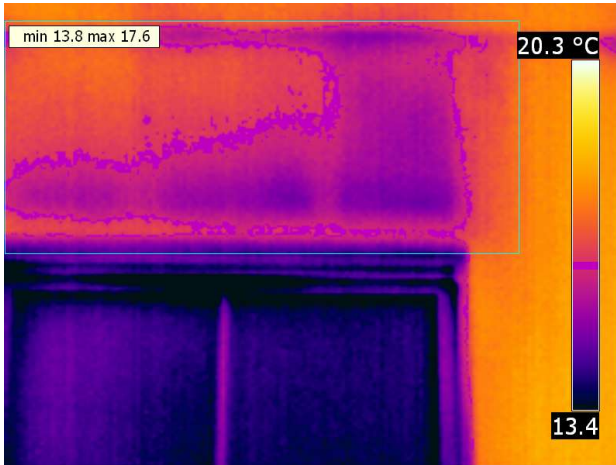
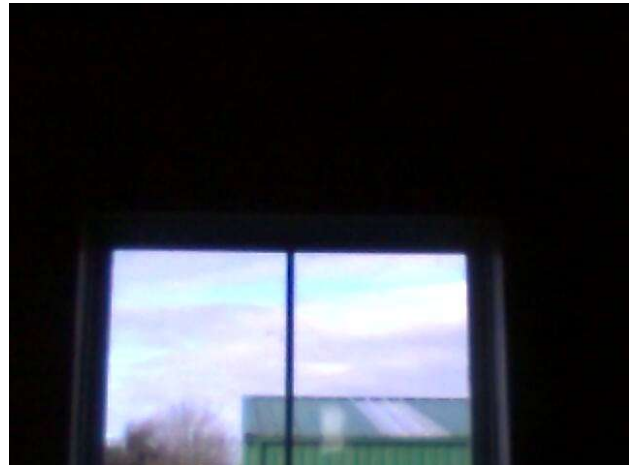
Image and Object Parameters		Text Comments
Camera Model	FLIR ThermaCAM B2	
Image Date	2008:03:19 10:58:36	
Image Name	IR_0133.jpg	
Emissivity	1.00	
Reflected Temperature	20.0 °C	
Object Distance	2.0 m

Description
Image shows an area of thermal bridging above window. Thermal Imaging is highly useful for building energy loss analysis.
